# Manhole Inspection Summary

Manhole # S15GG2007MH

Insp Date: **7/5/06 4:24 PM**

**Location** Address: **6108 MAYWOOD AVE**

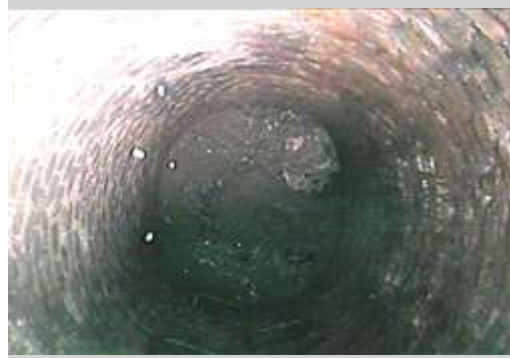
Top View

Corroded and missing steps. Channel debris.

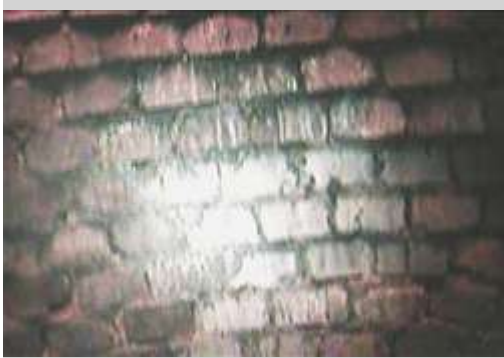
Defect

Corbel and Barrel deterioration and infiltration.

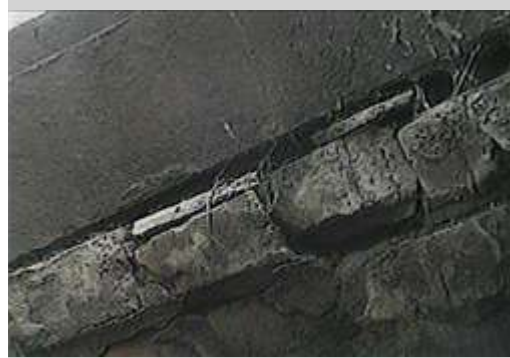
Defect

Frame leaks. Adjustment deterioration, loose brick, root intrusion and infiltration.

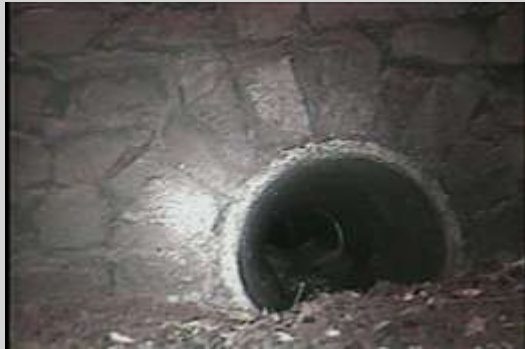
8 in. Circular Gravity Sewer  
Pipe Out @ 12 O'Clock

Barrel deterioration and infiltration.
